High Level Sewershed

Run Summary —					Ground	Notification		
Test ID	Test Type	Date Inspected	Company / Super.	Nearest MH	Condition	Made?	1	
D1028-165	Dye	4/23/2009	ADS/TM	S13EE1016MH	Damp	NA		
Address 400	00 Pimlico Road		Location	Curb	Status P	ublic	Source	Catch Basin

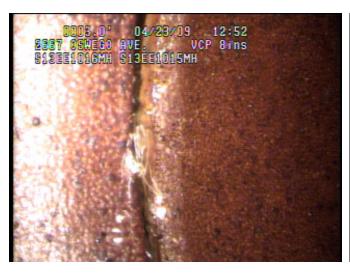
Picture \D1028-165-OB01-P01.jpg

Obs_ID D1028-165-OB01 **Nearest MH** S13EE1016MH

Comments Dye observed 3.0 ft. downstream of S13EE1016MH.

Infiltration runner at joint at 10 oclock.

Comments 3.0 ft. downstream of S13EE1016MH along

S13EE1016G1.

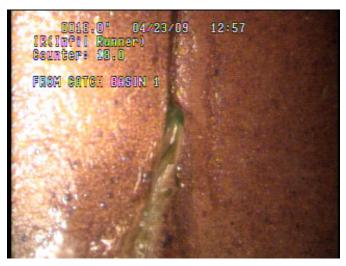
Picture \D1028-165-OB03-P01.jpg

Obs_ID D1028-165-OB03

Comments Dye observed 18.0 ft. downstream of

S13EE1016MH. Infiltration runner at joint at 10

oclock.

Comments 18.0 ft. downstream of S13EE1016MH along

S13EE1016G1.

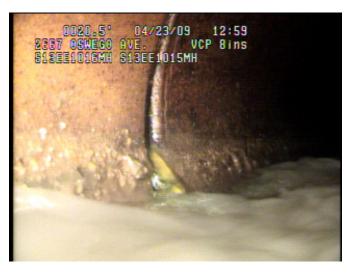
Picture \D1028-165-OB05-P01.jpg

Obs_ID D1028-165-OB05 **Nearest MH** S13EE1016MH

Comments Dye observed 20.5 ft. downstream of

S13EE1016MH. Infiltration runner at joint at 8

oclock.

Comments 20.5 ft. downstream of S13EE1016MH along

S13EE1016G1.
